# Final Stage Unit Replacement

If your interior heat/AC ventilation fan either works intermittently or only at a single speed regardless of the setting, you probably need to replace what BMW calls the "final stage unit." It's part number 64-11-8-385-549 (new part number 64 11 6 929 486). Cost is under \$100.

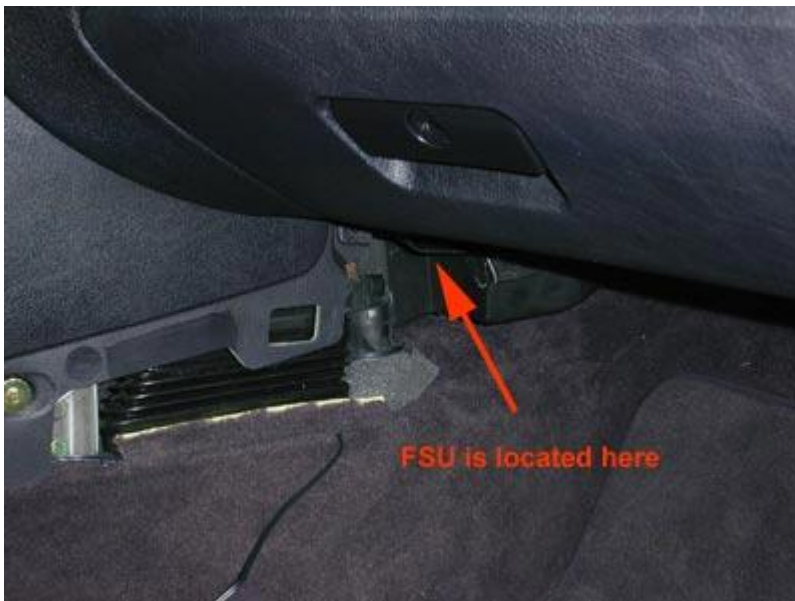
The final stage unit is located to the left of the glove box, under the center of the dash near the firewall.

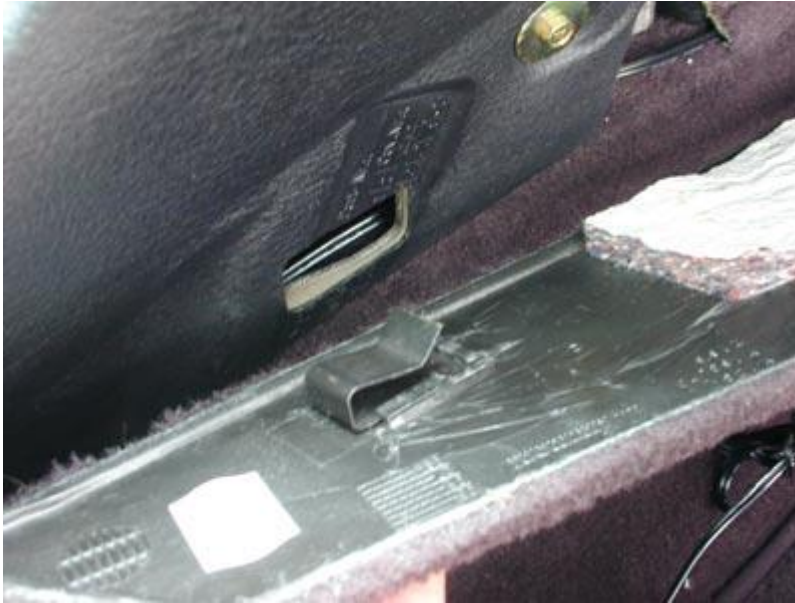
- one near the front, and one near the rear. The picture below shows how the clips are positioned and fit into the slots. Once the clips are clear, the bolster should come off easily. Don't force it. If you break the clips the bolster will not stay in place and it's almost impossible to fix them. Pulling the plastic panel under the glove box also will give you more room to work (pulls straight out toward you).

Access is from the passenger side of the car (driver's side on right-hand drive cars.) You'll first need to remove the carpeted bolster that runs along the side of the center console (on right-hand drive cars, you'll need to pull the plastic panel over the pedals to do so). Remove the visible screw and then slide the bolster toward the rear of the car to release the clips that hold it to the center console. There are two clips

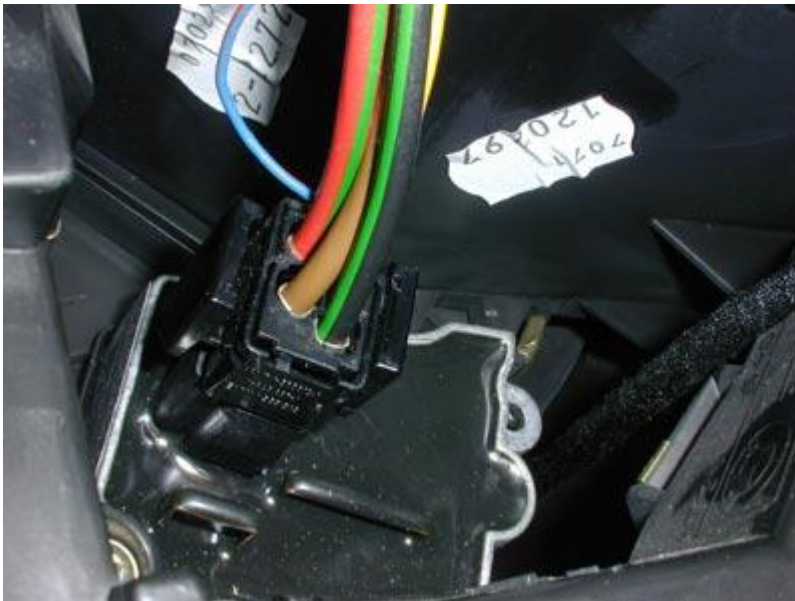
Once the bolster is off, look up under the center of the dash, just above the transmission tunnel. You should be able to see the plug for the unit as shown below.

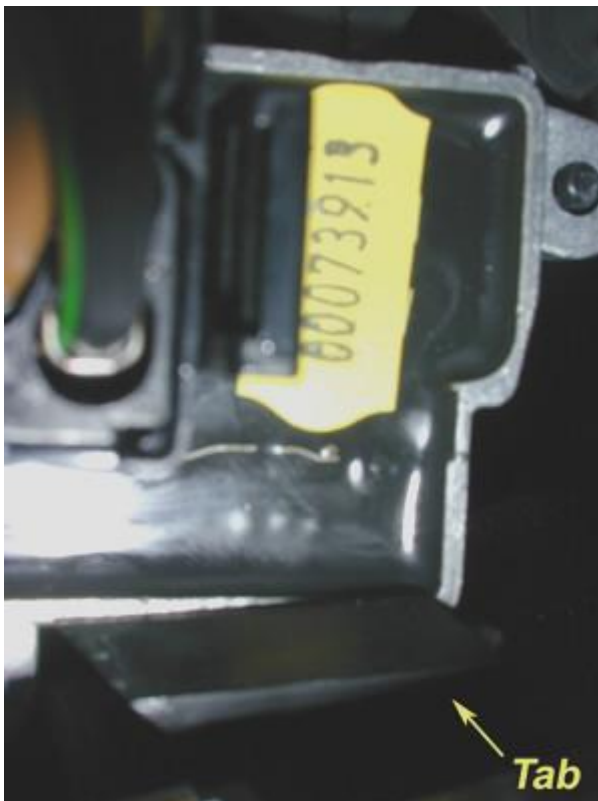
A closer view of the tab is shown below.
