### Accessing service information using service interval indicator

**Engine code:** N46 B20B

**Model:** 3 Series (E90/91/92/93) 2,0 320i

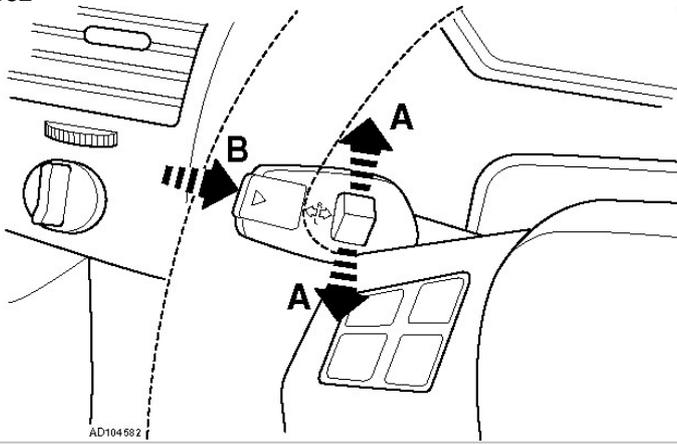
AD104582

Lightly press button [A] **104582** up or down until the service symbol [B] **104587** is displayed and "SERVICE-INFO" appears in the odometer display [C].

Press button [B] **104582**.

Press button [A] **104582** up to display next service item.

Press button [A] **104582** to display next service item.

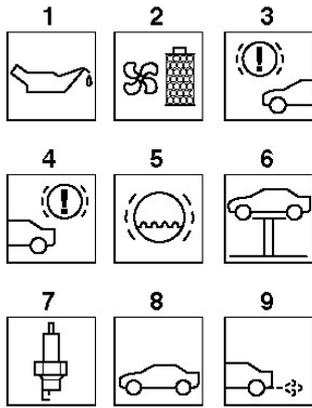
AD103769

The first service item symbol **103769** will appear and the date and distance to next service are shown in the odometer display.

- 1 Engine oil
- 2 Microfilter (Pollen filter)
- 3 Front brake pads
- 4 Rear brake pads
- 5 Brake fluid
- 6 Vehicle check
- 7 Spark plugs
- 8 Stat. vehicle insp. (MOT test)
- 9 Stat. exhaust. insp.

Press and hold button [A] **104587** for approximately 10 seconds until first service item is displayed **103769**.

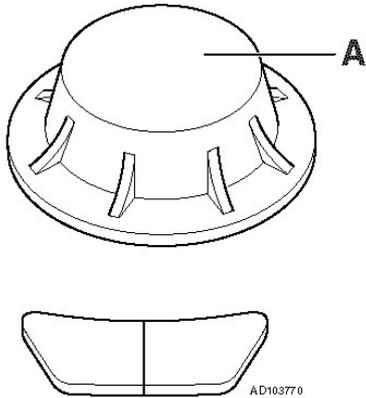
103770

Press i-drive controller [A] **103770** to display "i menu".

Turn i-drive controller [A] until the message "Service" is displayed.

Press i-drive controller [A] to select "Service".

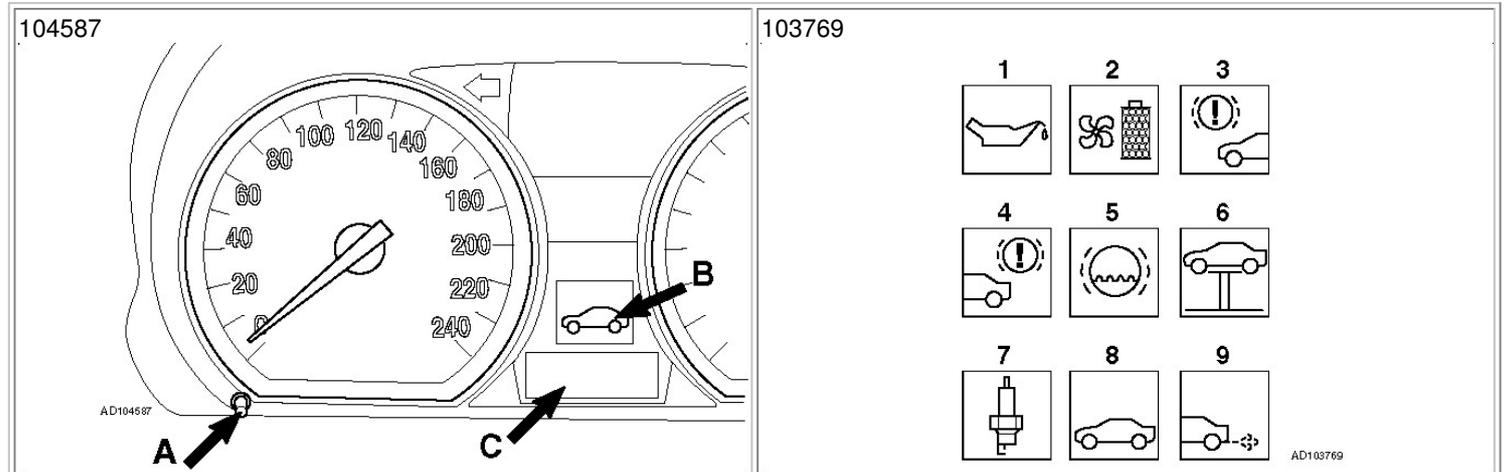
If displayed service item is to be reset: Press and hold button [B] for 3 seconds until the message "Reset?" is displayed.

Press and hold button [B] again for at least 3 seconds.
